National Dam Inspection Program. Oneida
Mining Co. Dam (NDI PA-830), Ohio River
Basin, Unnamed Tributary to Brush Creek,
Indiana County, Pennsylvania. Phase I
Inspection Report.

PHASE I REPORT
NATIONAL DAM INSPECTION PROGRAM

Oneida Mining Company Dam

26 September 78 (visual inspection)

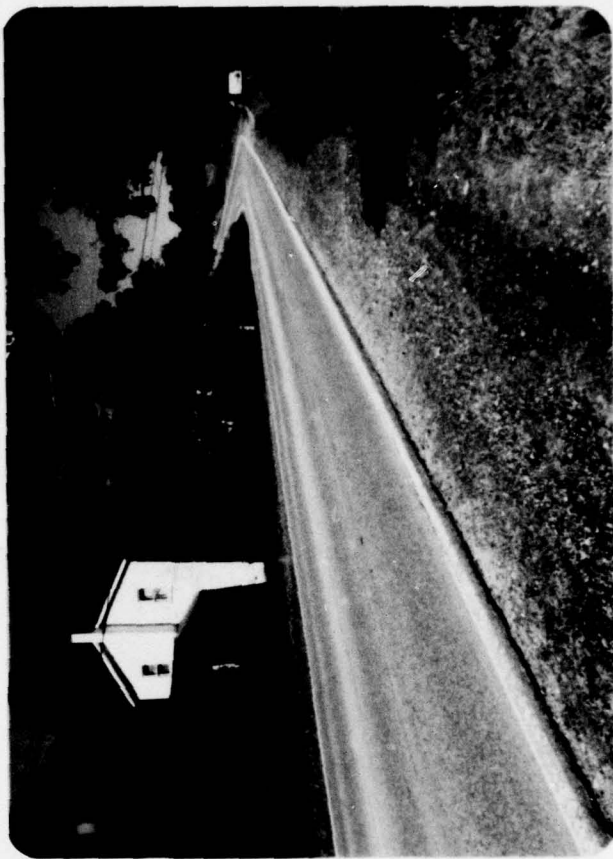
12

This view shows two dwellings located on the floodplain approximately 3 miles downstream of the embankment. Brush Creek passes beneath State Route 56 through a box culvert just right of center.
